Support to Project Preparation for Environment and Climate Change Sector, Montenegro

Rehabilitation of Biogradsko Lake Analysis of the existing condition and processes that may lead to its permanent devastation

PROJECT NO.	DOCUMENT NO.				
SPASS04	ENG_PPF_Biogradsko lake Draft Final Report				
VERSION	DATE OF ISSUE	DESCRIPTION	PREPARED	CHECKED	APPROVED
1.0	01/03/22	Draft Final for comments	VD, PT	RMFRX	CHJ
	29/03/22	Final for approval

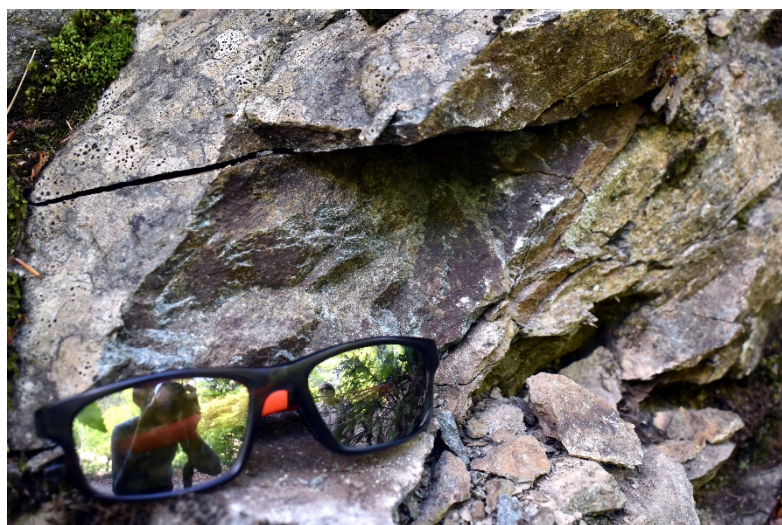
Figure 6. Permian sediments
(Photo: Dubljevic V., 2021)

The largest part of the Permian terrain is built by sandstone and schist. Out of the listed lithological components, the most represented are mica, quartz and conglomeratic sandstone.

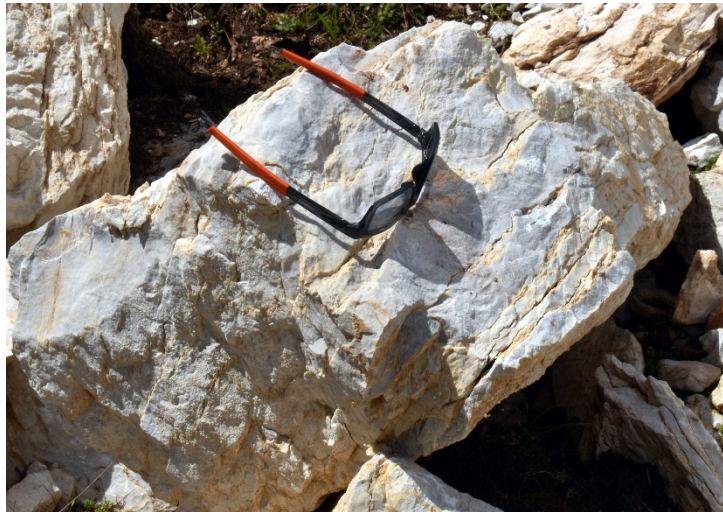
Figure 7. Triassic massive crystal limestones
(Photo: Dubljevic V., 2021)

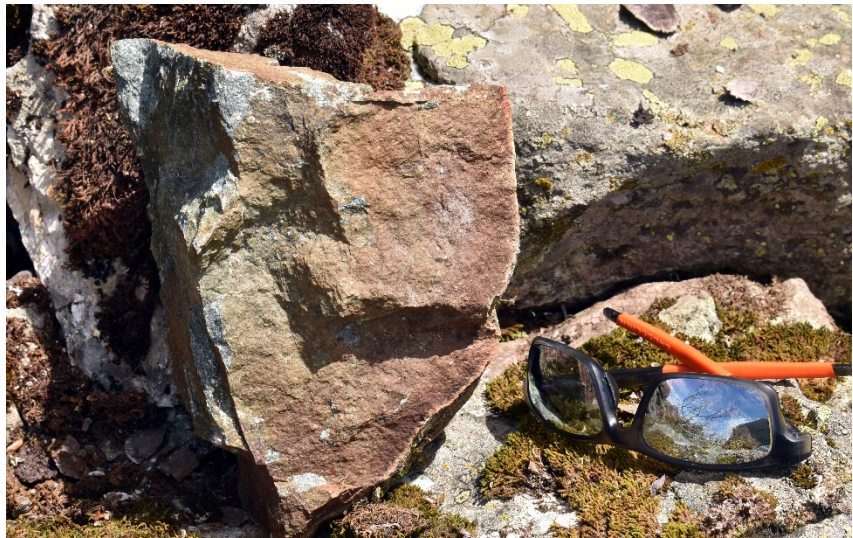
Figure 9. Magmatic rocks
(Photo: Dubljevic V., 2021)

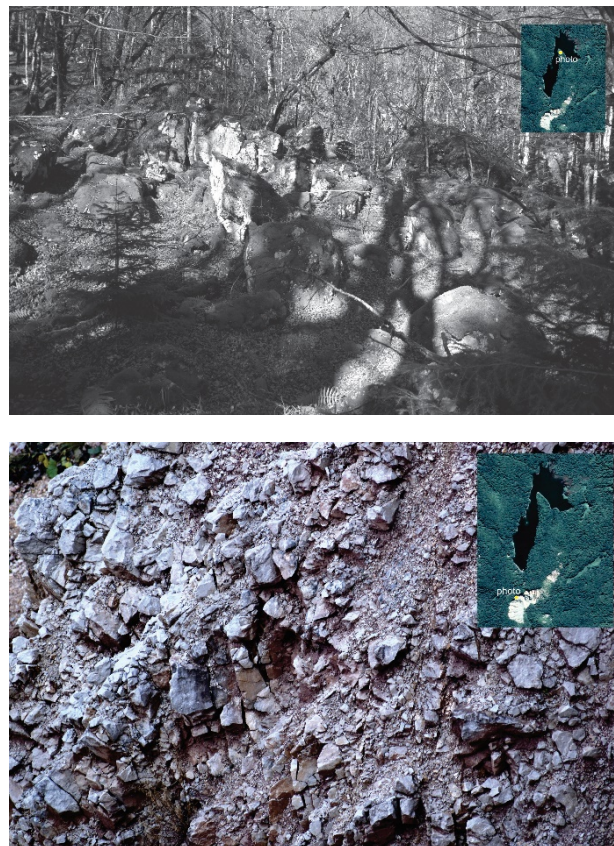
Moraines occur as a consequence of the glacial erosion or movements of glaciers during the last Ice Age (Pleistocene). The moraine material is represented by rock blocks, gravel, sandy clay and pebbles of various mineralogical and petrographic composition resulting from a diverse geological composition of the foundation along which the glacier moved eroding thereby the rock mass on its route and accumulating it in the area of reduced energy in the form of frontal moraine partitioning the glacial through, and lateral moraines. Rocks belonging to vulcanites, volcanogeno-sediment formation T_2^2 , limestones T_2^2 can be found in the composition of the moraine material, and a smaller amount of Permian sediments can also be encountered in the material. Thickness of the moraine material can range from several meters to 50 m.

Figure 10. Limestone blocks in lateral moraine (a) and moraine material (b).

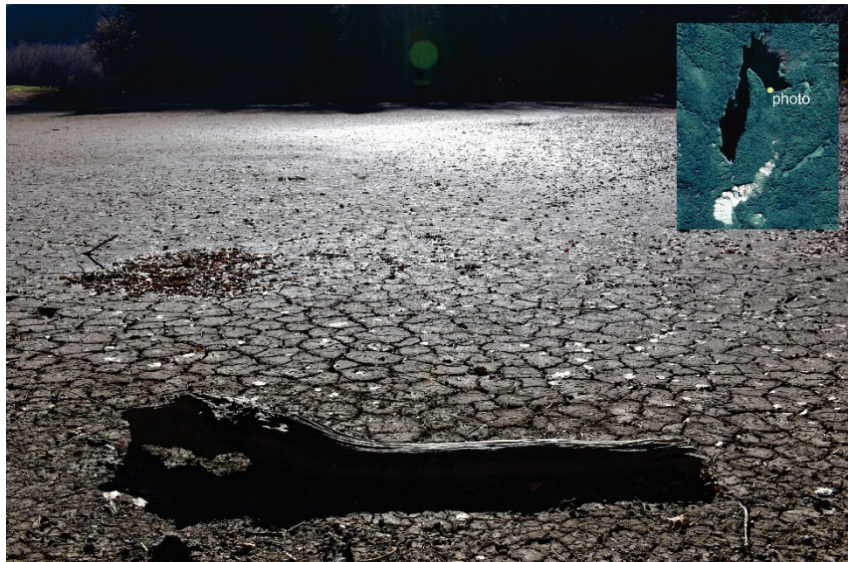
Alluvial sediments in the Biogradska River delta are flooded by Biogradsko Lake during most of the year resulting in the occurrence of crossed sedimentation due to deposition of finer particles in the Lake conditions and coarse particles brought by the Biogradska River.

Figure 11. Fine lake sediments covering alluvial sediments
(Photo: Dubljevic V., 2021)

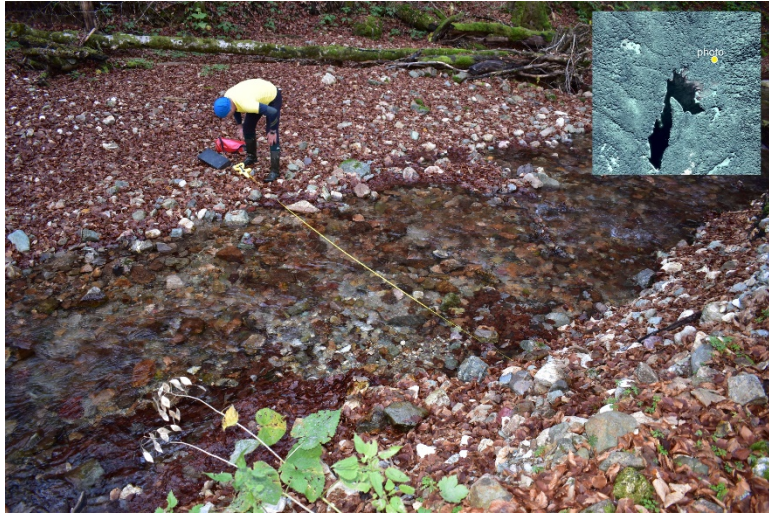
Going upstream the Biogradska Riverbed, increasingly large material is encountered in the alluvial sediment as a consequence of increased erosion energy of the river course. Considering that the estimated maximum, hundred-year flow of the Biogradska River amounts to 127.70 m³/s, and of the Lalev Stream amounts to 29.60 m³/s, finding boulders which may be even one meter in size in the riverbed is logical. Due to lasting destructive effect of the River, downstream section of the riverbed is completely silted with sediment in the length of around 900 m, from the mouth of the Biogradska River into the Lake, as a consequence of a sudden change in the longitudinal inclination of the bed.

Figure 12. Coarse alluvial sediments in the Biogradska Riverbed
(Photo: Dubljevic V., 2021)

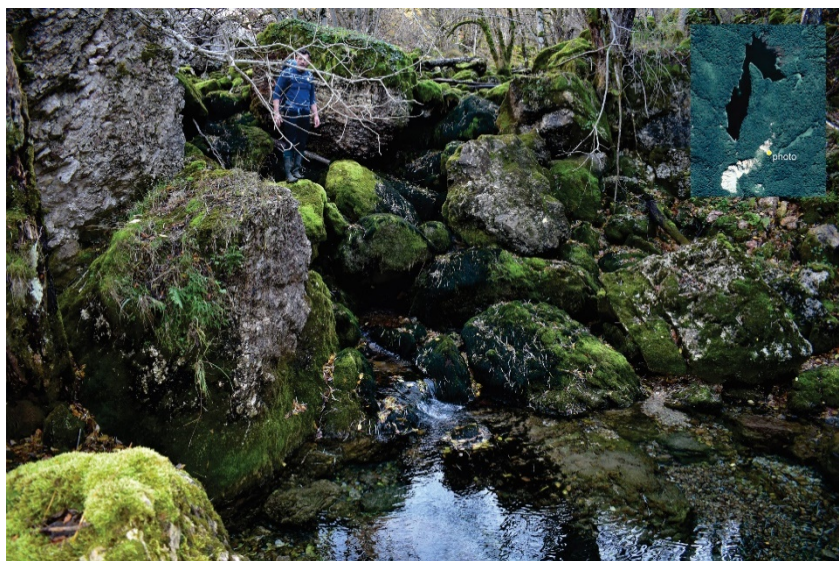
The River Jezerštica is formed due to lateral overflow from the Lake and based on emerging of water through unconsolidated source area at the foot of the large erosion shell. Based on the calculation (Nikčević, Ristić 2005), the value of high water of Jezerštica at the overflow amounts to $23.8 \text{ m}^3/\text{s}$. The large inclination of the river course caused Jezerštica to be characterized with high energy potential so alluvial sediments ranging from smaller to multi-meter large blocks are accumulated in its course.

Figure 13. Jezerštica bed at the place of continuous emergence of water

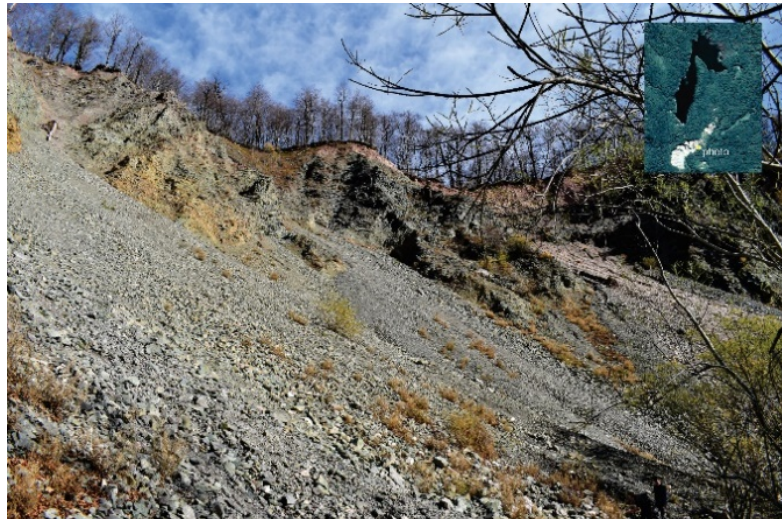
Deluvial sediment occurs on slopes as a consequence of surface decomposition of the bedrock and transporting of decomposed material by washing-off and gravitation to the foot of the slope. Therefore, rocks in the area of Biogradsko Lake are of varying petrographic and granulometric composition and are predominantly of eruptive and carbonate origin. Grains are semi-spherical, and it is not easy to separate them from glacial sediment in the field. The border between them is very often unclear. This inability of breaking them down is especially present in lateral moraines around Biogradsko Lake. In some places, along the Lake shore, material belonging to glacial sediment is masked (covered) by deluvial sediment of small thickness, which is eroded and accumulated there in the period after completion of movement and melting of glaciers.

Figure 14. Deluvial sediment

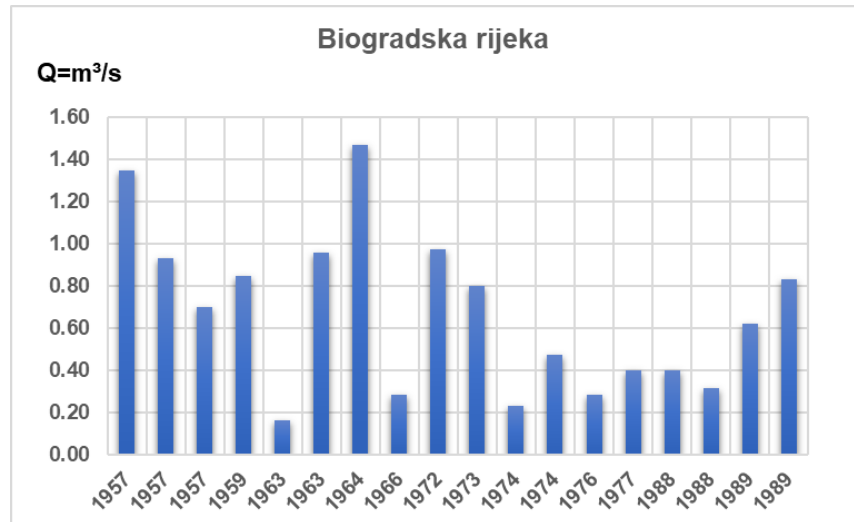
5 m³/s of water flows to the basin, while at the minimum flow this volume drops to approximately 100 l/s.

Figure 24. Values of water flows on the Biogradska River – historical data (IHMS)

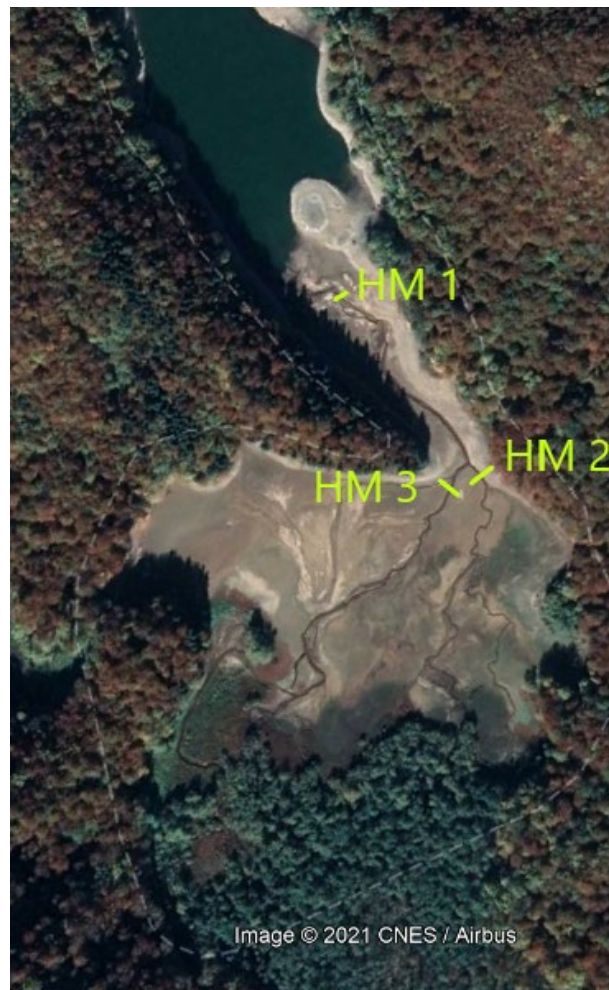
Certain hydrometric measurements on the Biogradska River were performed in October and November 2021 in order to review samples and consequences of the reduction of the water area of Biogradsko Lake, and to link certain phenomena and processes in the basin. Characteristic values are presented in Table 3. An overview of water gauging stations (GoogleEarth) is shown on Figure 25.

Figure 25. Locations of water gauging stations

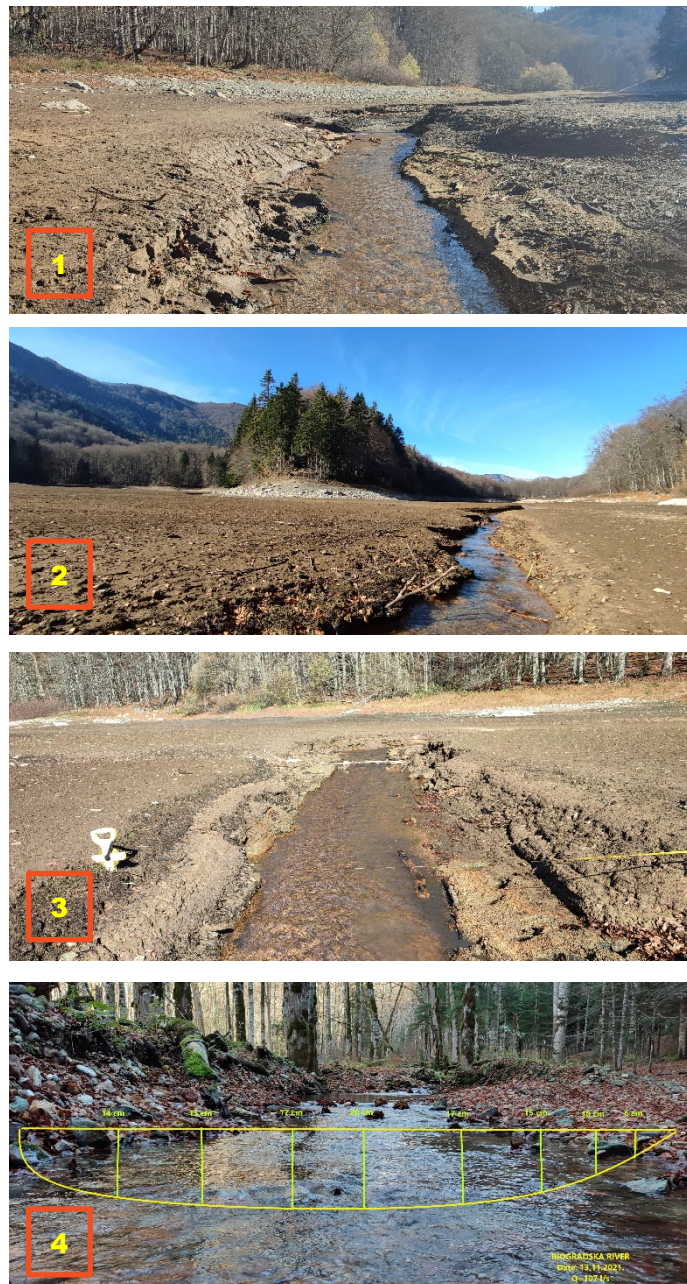
Measurements were performed by mini current meter (AOTT) and by using the “surface-velocity” method under ISO 748. These measurements provided a current insight into the intake regime of the Biogradsko Lake in the hydrological minimum.

Figure 26. Hydrometric profiles on the Biogradska River
(Photo: Culafic G., 2021)

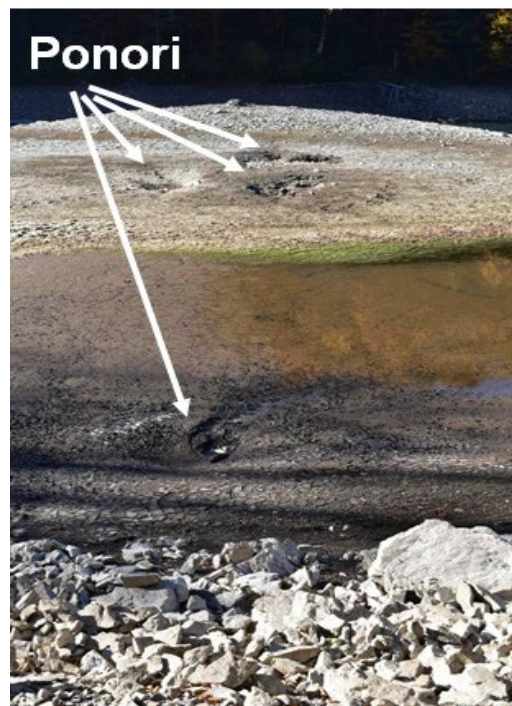
The hydrogeological map 1:5000 should include directions of circulation of ground water. This especially relates to the water infiltrating through sinkholes along the bottom of Biogradsko Lake and probably emerging on Jezerštica springs in the canyon of the same name. It is necessary to perform dyeing experiment by means of a tracer in order to identify routes of circulation of ground waters.

Figure 32. Sinkholes which would allow pouring of tracer
(Photo: Dubljević V., 31.10.2021)
